Downgraded at 3 year
intervals; declassified
20 years**RESEARCH MEMORANDUM**FLIGHT OBSERVATIONS OF AILERON FLUTTER AT HIGH MACH
NUMBERS AS AFFECTED BY SEVERAL MODIFICATIONS

John R. Spreiter, George M. Galster,
and George E. CooperAmes Aeronautical Laboratory
Moffett Field, Calif.

April 25, 1947

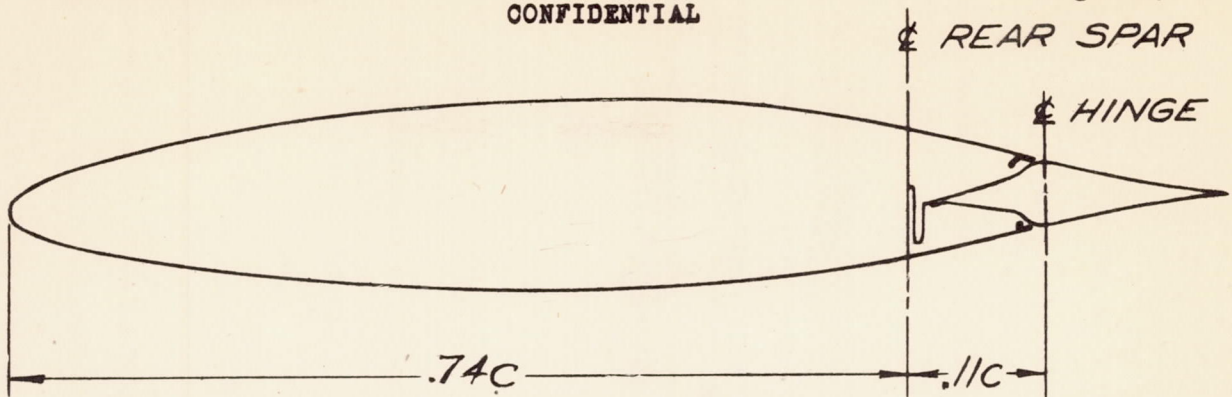
aileron section, balance, and seal, is presented in figure 3. Since the only change in airfoil and aileron section along the aileron span is a slight change in camber, this view may be considered typical of the entire wing-aileron combination. The general specifications of the wing and aileron combination are as follows:

FIGURE 3. - CROSS SECTION OF WING AND AILERON.

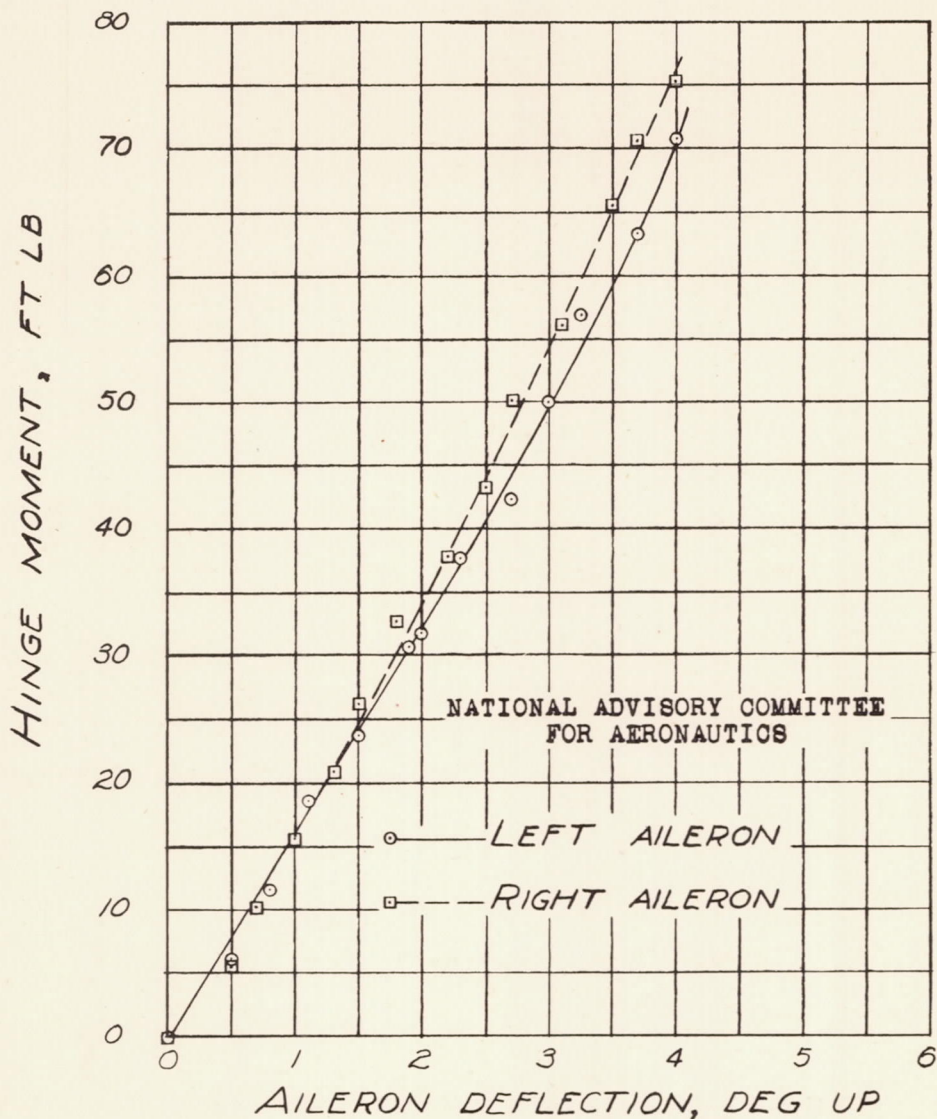
The aileron control system was of the push-pull rod type. The variation of aileron deflection with hinge moment, as measured in static ground tests with the control stick locked, is shown in figure 4.

An analysis of the variation of aileron angle with Mach number (fig. 7) in relation to the elastic characteristics of the normal control system (fig. 4) shows that as the Mach number increases from 0.30 to 0.72 at an altitude of 10,000 feet, the aerodynamic hinge moment applied on the left aileron increases from 3.0 to 13.5 foot-pounds, corresponding to hinge-moment coefficients of 0.005 and 0.004, respectively. The relative constancy of the hinge-moment coefficient at Mach numbers less than 0.72 indicates that the gradual upfloating of the ailerons in this range is essentially a function of dynamic pressure rather than an effect of compressibility.

FIGURE 4- VARIATION OF AILERON DEFLECTION WITH AILERON HINGE MOMENT WITH CONTROL STICK LOCKED. NORMAL CONTROL SYSTEM.

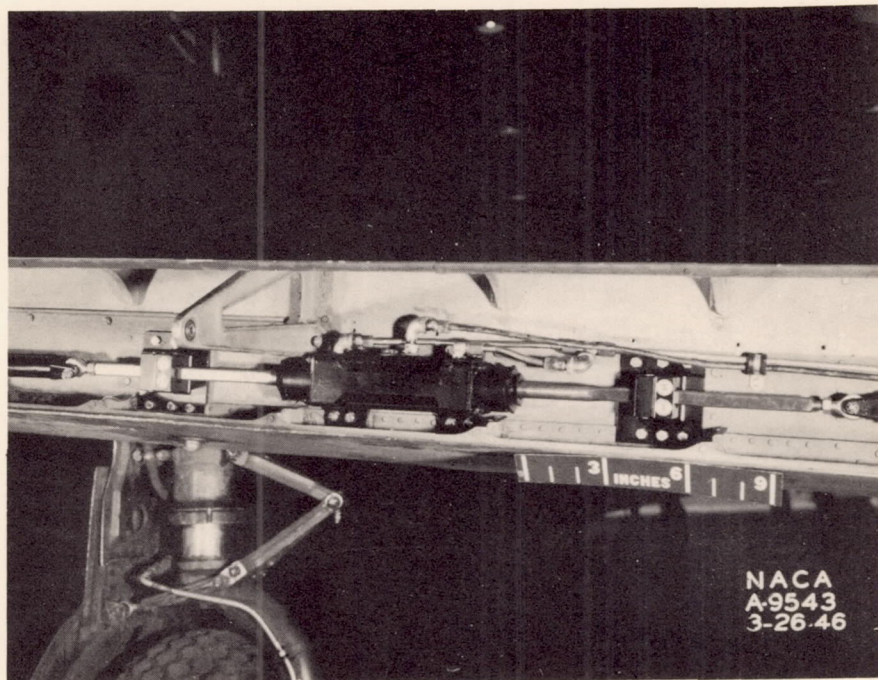
Figure 5.- The irreversible unit, as installed
on the test airplane.

The original aileron control system was modified for a portion of the tests by installing an irreversible unit on the rear spar of the wing 2 feet inboard from each aileron bell crank. A photograph of the installation is shown in figure 5. This mechanism, designed and constructed at the Ames Aeronautical Laboratory, operates on the hydraulic-lock principle, the relief valves being actuated only by motions of the control stick. Due to imperfect fluid seals, this mechanism could not completely lock the ailerons; an applied aileron hinge moment of 10 foot-pounds caused the aileron to creep approximately 7° per minute. In addition, it was possible to move the ailerons approximately 1° without transmitting the motion past the irreversible unit. This movement was traced to backlash in the rod-end bearings and the hydraulic unit, and to distortion of the rear spar web supporting the bell crank. The total friction in the aileron control system with irreversible units installed on both ailerons was equivalent to a control force of approximately 6 pounds.

With the irreversible aileron control system, three dives were made to the point of severe airplane buffeting during the course of one flight. At the conclusion of this flight, it was discovered that a large amount of play had been produced in the bell-crank bearings and the aileron attachment fittings. Consequently, it was not considered safe to continue the flight tests and no further development of irreversible aileron control systems was attempted.

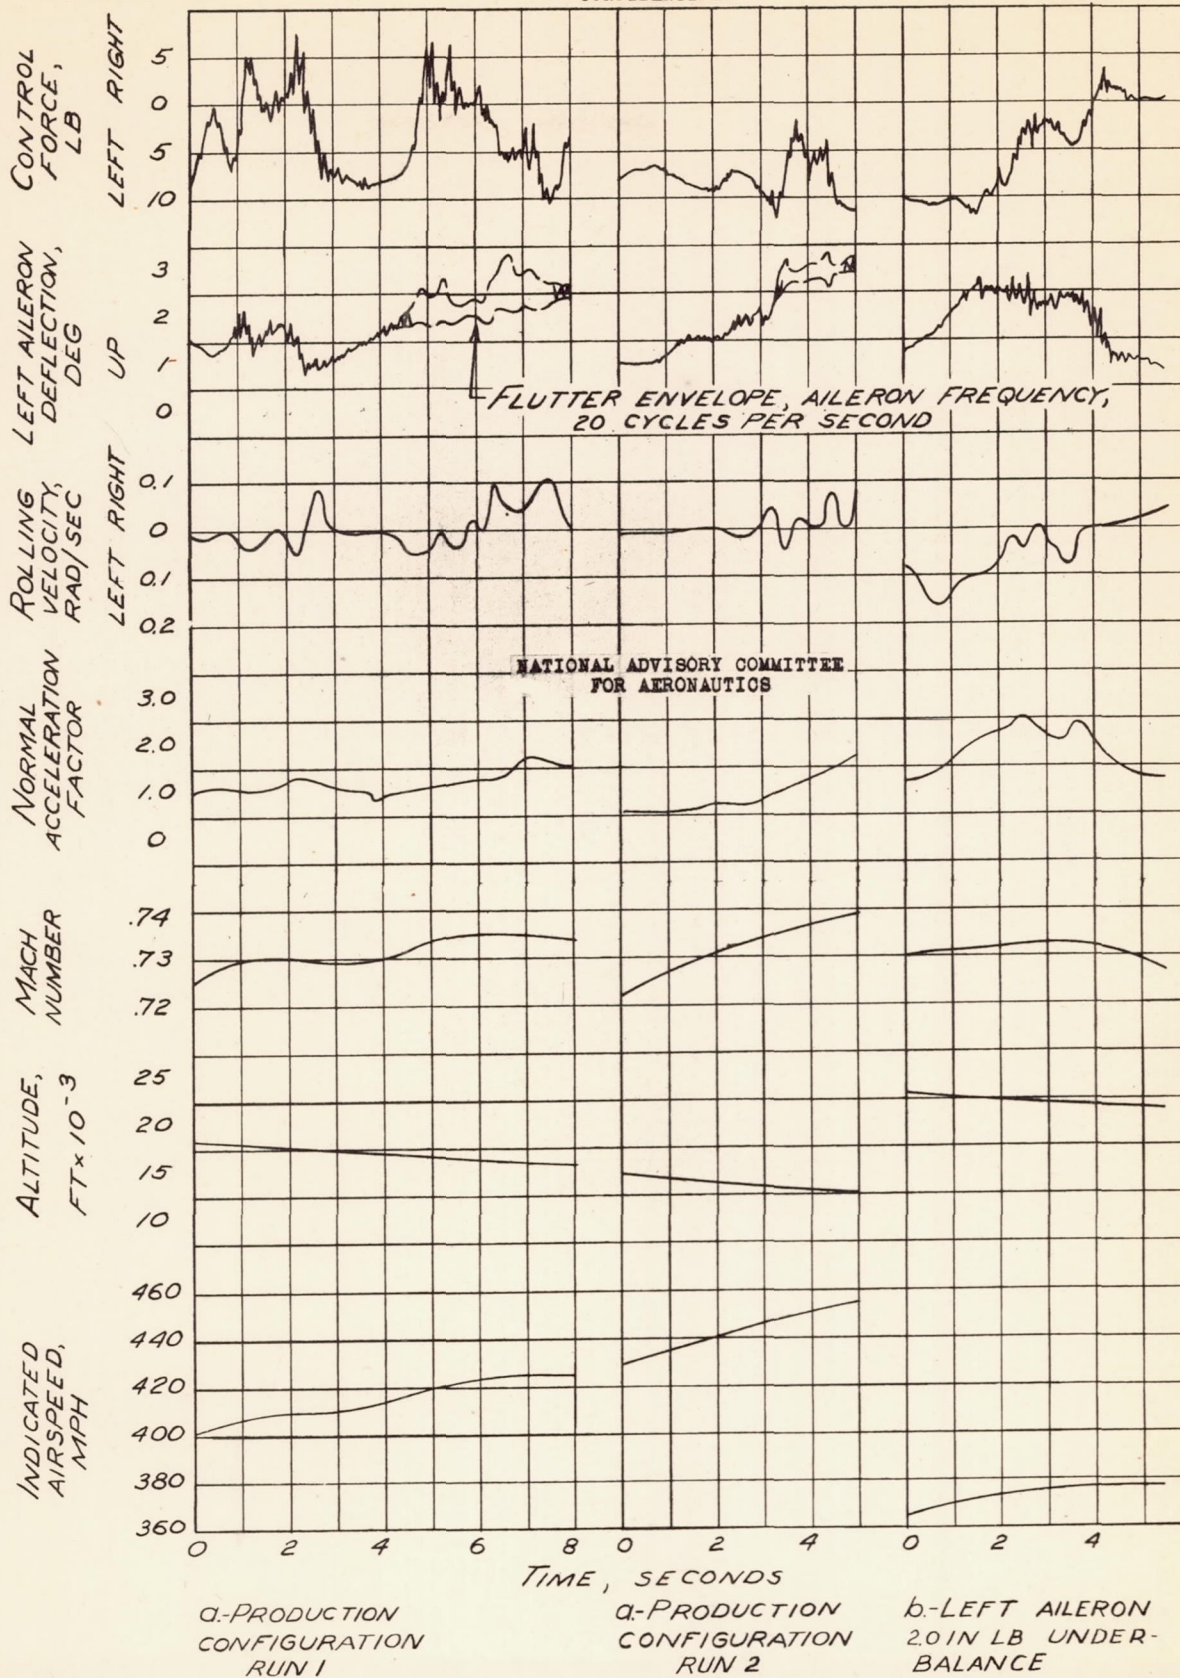
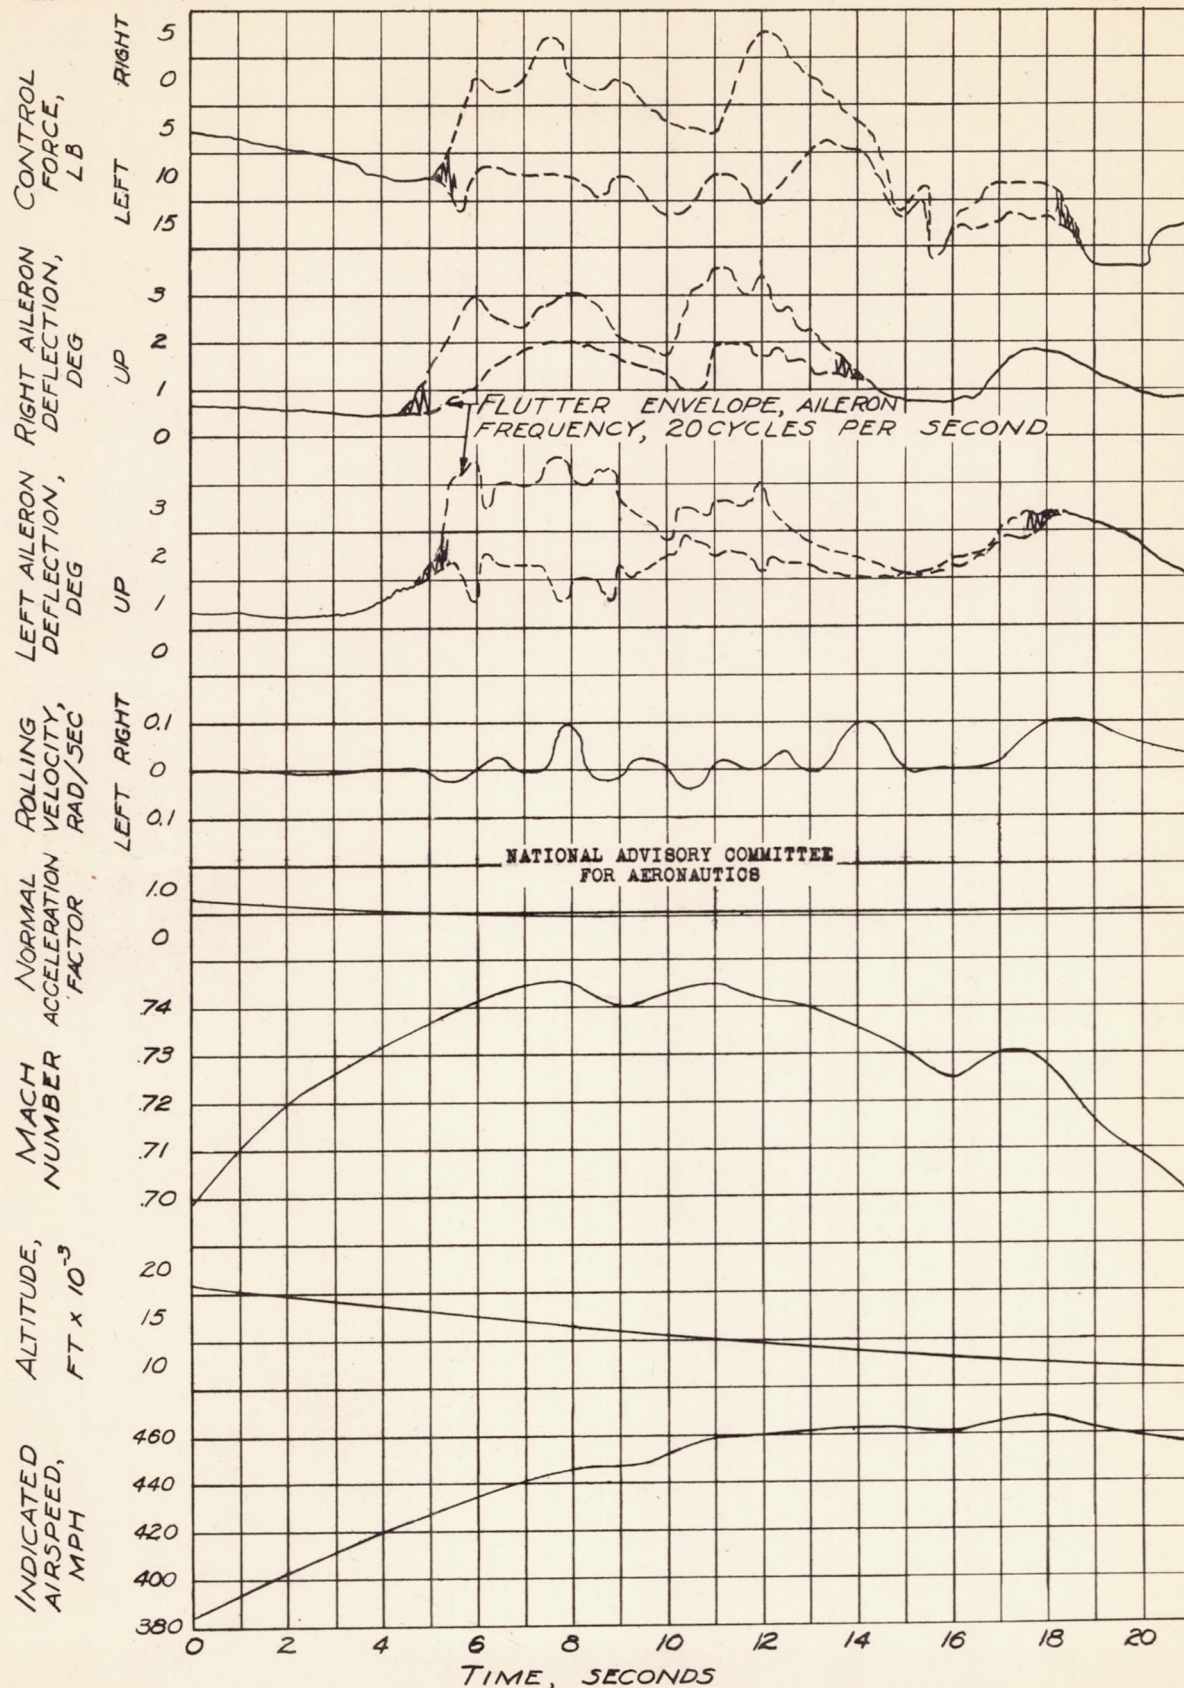
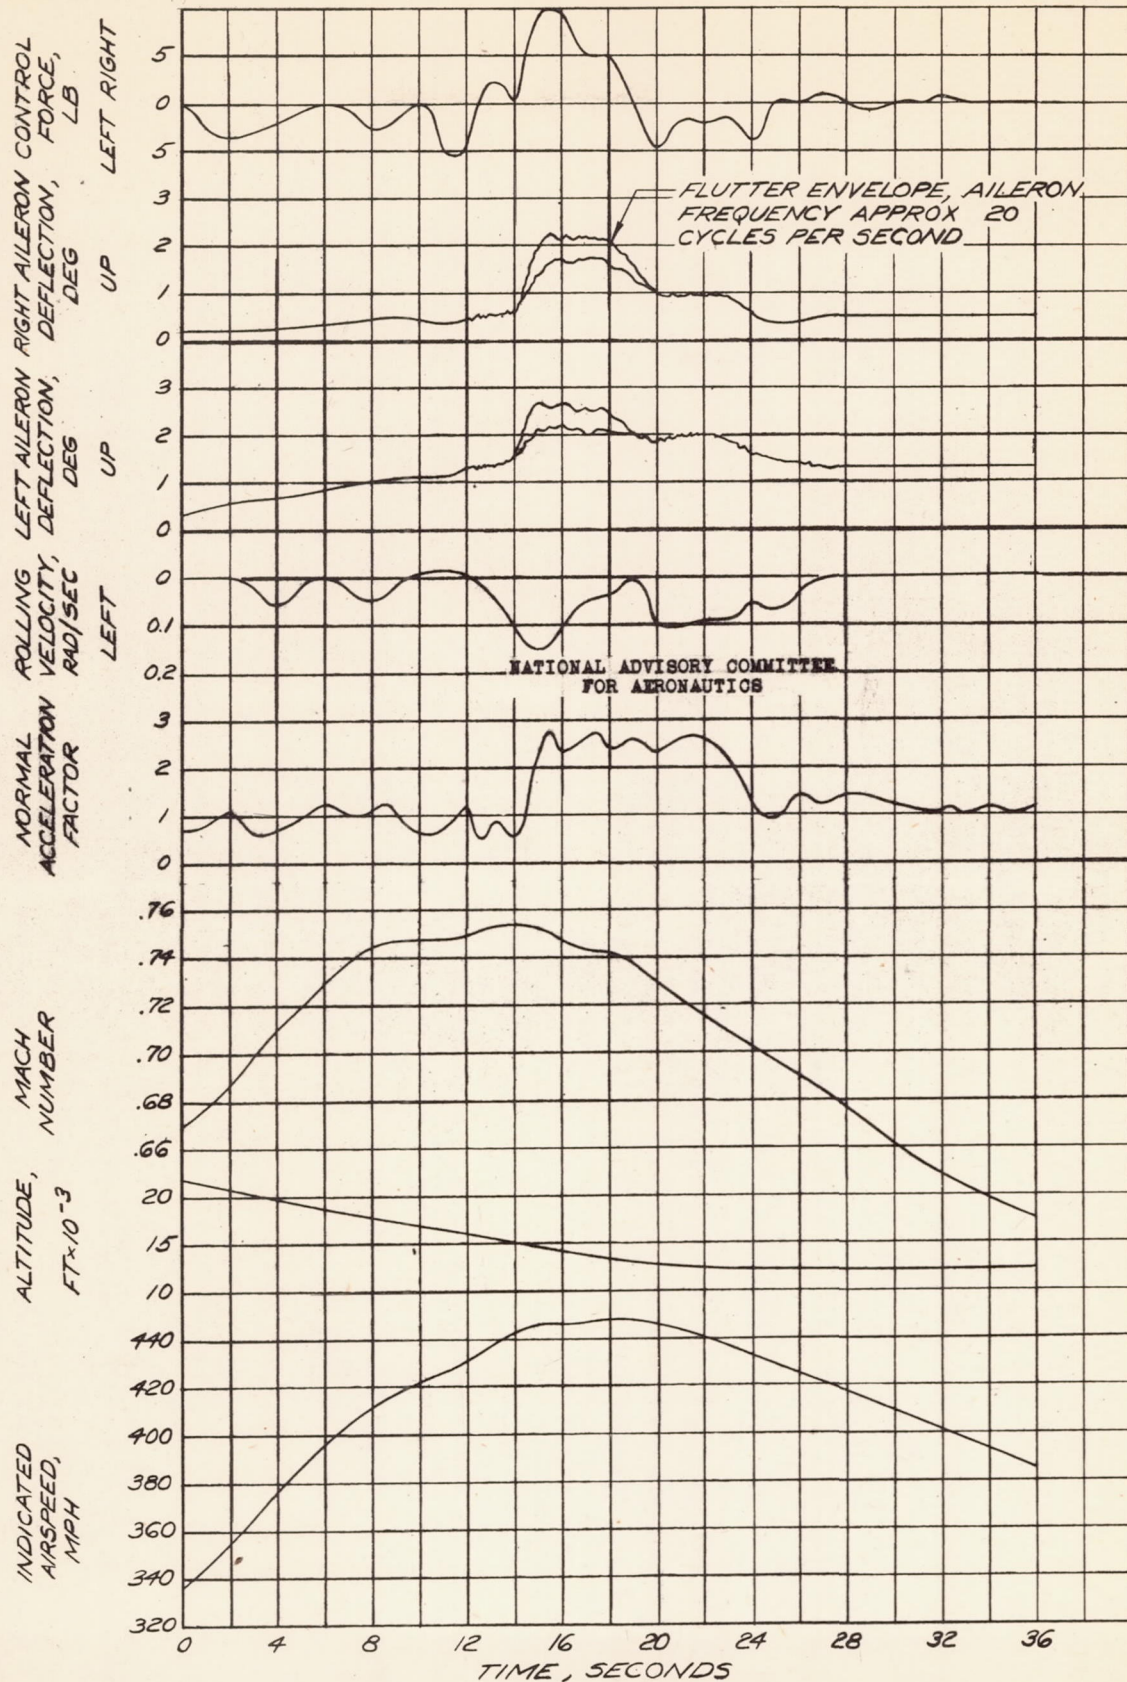
FIGURE 6. - TIME HISTORIES OF TYPICAL AILERON FLUTTER.

Although the time histories for the normal control system (figs. 6(a), 6(b) and 6(c)) show that the flutter amplitude was the least when the left aileron was mass-underbalanced and the greatest when the pressure seals were removed, these variations in flutter amplitude may also be correlated with the variations of Mach number since the greater amplitudes always occur at the higher Mach numbers.

Further analysis of the time histories for the normal control system (figs. 6(a) through 6(c)) indicates that the aileron flutter phenomenon was characterized by the following sequence of events. As the Mach number was increased beyond 0.72 both ailerons started floating upward. At a Mach number of about 0.73, an incipient aileron flutter occurred, which at a slightly higher Mach number developed a steady frequency of about 20 cycles per second; further increases of Mach number up to 0.745 resulted only in a greater amplitude of the vibrations. Despite changes of indicated airspeed from 365 to 460 miles per hour, both the onset and the disappearance of flutter always occurred at a Mach number of about 0.73.

Records taken during the tests with the irreversible control system (fig. 6(d)) show that the same upfloating tendency appeared prior to the flutter as was noted with the normal control system. The onset of flutter, however, was postponed to a Mach number of 0.75 and the amplitude was limited to less than a degree. It should be noted that this

flutter amplitude (approximately 1°) corresponds roughly to the amount of play in the irreversible aileron control system. While the test irreversible control system failed to prevent completely the aileron upfloat and flutter, it is felt that their occurrence was the result of deficiencies in the irreversible control system. Were a completely irreversible control system installed, it is believed that no flutter nor upfloat would occur. This belief is substantiated by the fact that the rigidly held landing flaps were never reported to flutter.

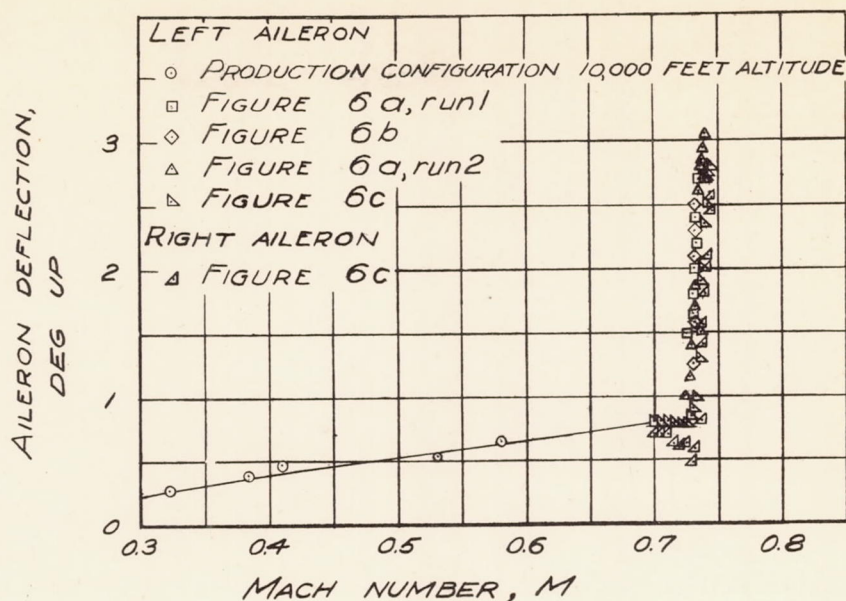
FIGURE 7.— VARIATION OF AILERON FLOATING ANGLE WITH MACH NUMBER IN STEADY FLIGHT. NORMAL CONTROL SYSTEM.

The variation with Mach number of the aileron angles measured in straight flight with the normal control system is shown in figure 7. These data show that at Mach numbers greater than 0.72, the effects of moderate changes of altitude, indicated airspeed, or aileron configuration are small in comparison with those of Mach number. Similar data for the irreversible control system are not presented because, due to creep, the aileron angle is a function of the time rate of change of Mach number as well as of the Mach number itself. Insufficient data are available to present adequately this more complicated relationship. The time history of figure 6(a) does show, however, that the ailerons float upward in a manner quite similar to that indicated in figure 7 for the normal control system.

With further increases of Mach number to 0.74, however, the mean aileron hinge moment increases rapidly to approximately 50 foot-pounds, which, at an altitude of 10,000 feet, corresponds to a hinge-moment coefficient of approximately 0.015. Because of the marked change in the hinge-moment coefficient and because the ailerons with the normal control system always start their pronounced upward movement at approximately the same Mach number, it is concluded that the upfloating tendency at Mach numbers above 0.72 is due mainly to an effect of compressibility.

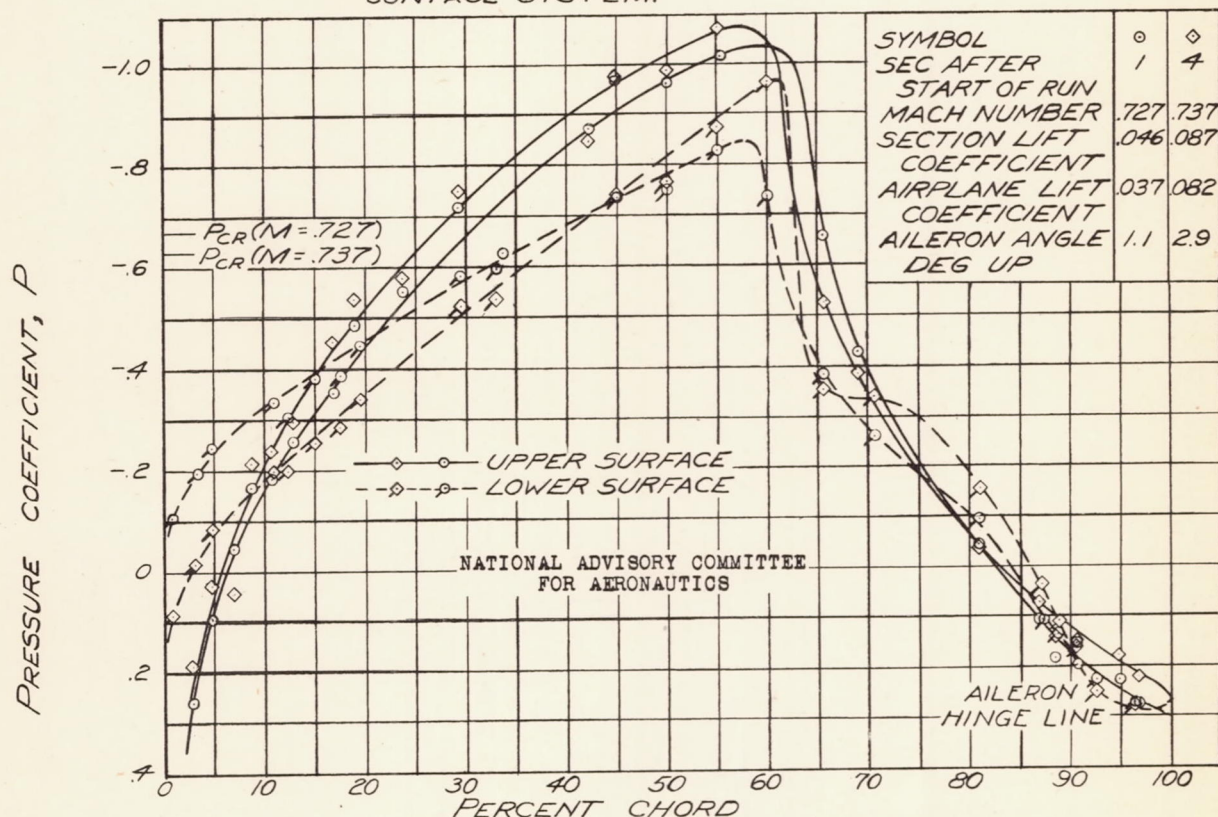
FIGURE 8.— TYPICAL PRESSURE DISTRIBUTIONS BEFORE AND DURING AILERON FLUTTER CORRESPONDING TO THE DATA SHOWN IN FIGURE 6(a) RUN 2.

Chordwise pressure distributions recorded 1 and 4 seconds after the start of the time history shown in figure 6(b) are

presented in figure 8 to show typical distributions before and during the occurrence of aileron flutter. Because of the damping and inertia in the pressure lines between the orifices in the wing and the manometer in the tail compartment of the fuselage, the pressure distribution recorded while the aileron was fluttering is somewhat inaccurate, but it does have significance as a mean pressure distribution.

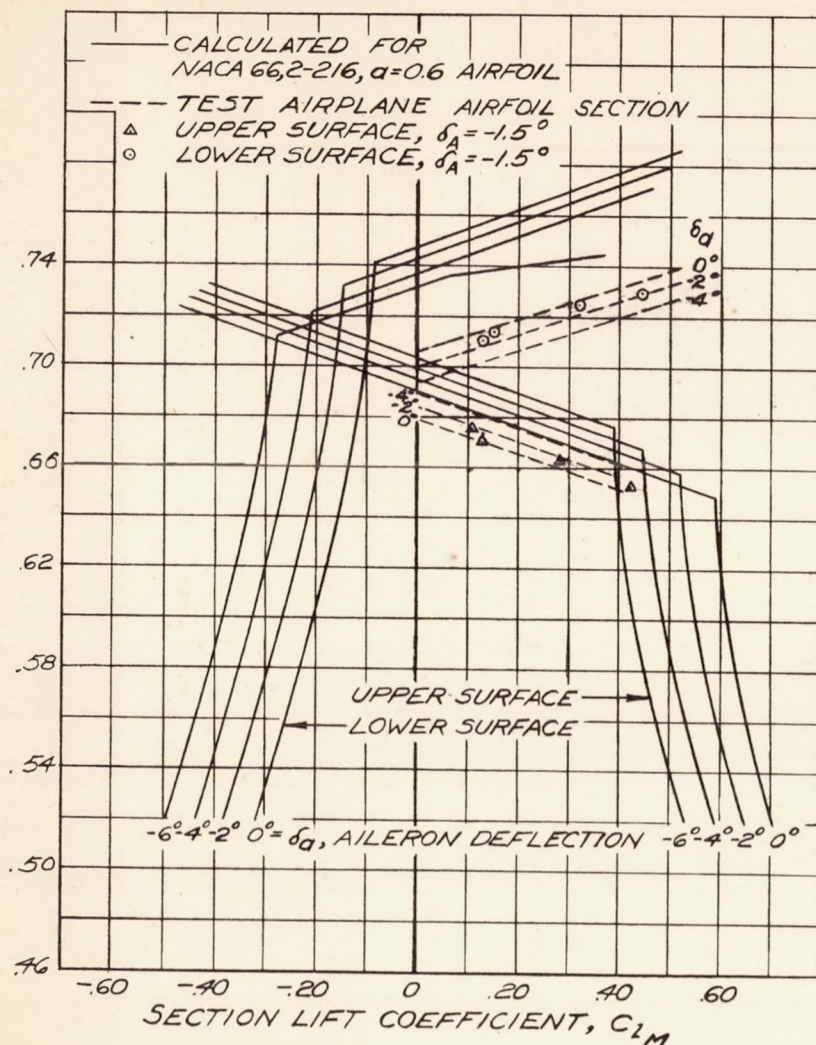
FIGURE 9.— VARIATION OF CRITICAL MACH NUMBER WITH HIGH-SPEED LIFT COEFFICIENT FOR VARIOUS AILERON DEFLECTIONS. NACA 66,2-216, $a=0.6$ AIRFOIL SECTION WITH 0.15C PLAIN FLAP AND THE TEST AIRPLANE AIRFOIL SECTION.

The data of figure 9 show that for positive lift coefficients and for negative aileron angles up to 4° , the

critical Mach number of the upper surface is always less than that of the lower surface. As a result, the magnitude of the shock-induced separation on the upper surface will probably be greater than that on the lower surface. Therefore, since the pressure coefficients on the rear portion of an airfoil on which the flow is separated from the surface are more negative than they would be without separation, the ailerons would tend to float upward as the critical Mach number is exceeded. The actual amount of upfloat would be determined by the degree of separation and by the elasticity of the control system.

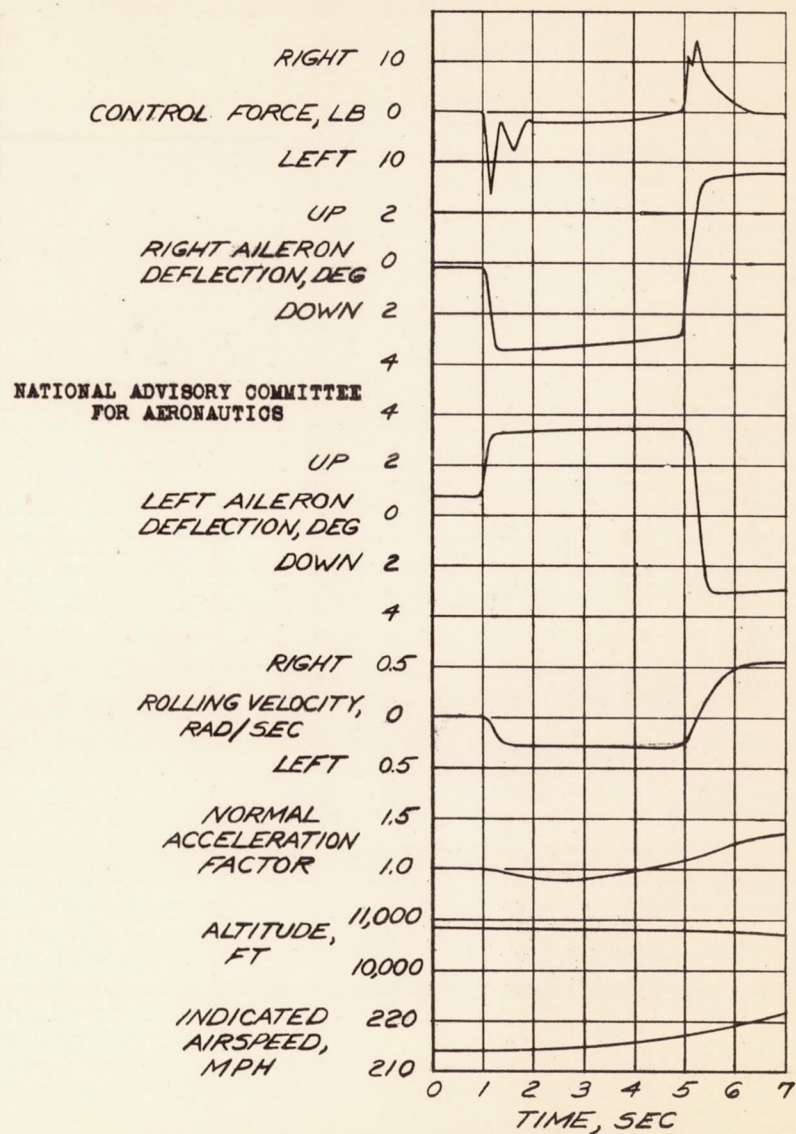
FIGURE 10.— TIME HISTORY OF TYPICAL ABRUPT AILERON ROLL. IRREVERSIBLE AILERON CONTROL SYSTEM.

Figure 10 shows a typical time history of an abrupt rudder-locked aileron roll of the test airplane with the irreversible aileron control system installed. This time history clearly shows the initial control force required to move the ailerons and to start the roll. Once the desired aileron deflection was reached, the control force was reduced nearly to zero, while the irreversible unit maintained the aileron at an effectively constant setting.
